# Test Report No. 403.388-3

**Test item:** Pipelife "Stormbox" in green colour

**Test specification:** Jetting test with standard nozzle at a pressure of 120 bar

## Test Report No. 403.388-4

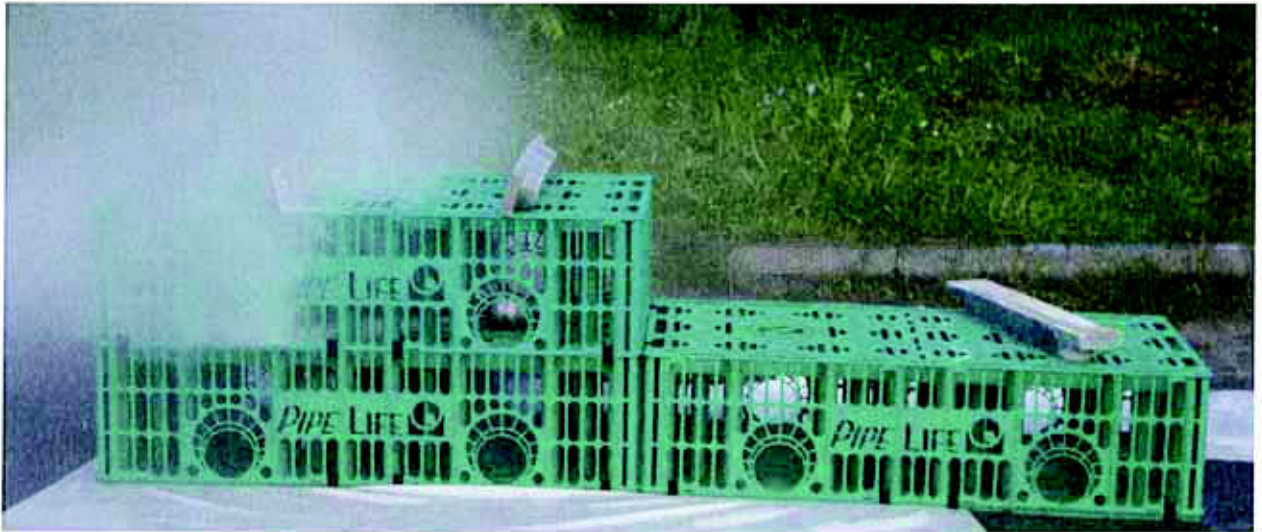
Picture 1: Test assembly

The test was carried out on three "Pipelife Stormboxes" connected to a testing assembly (picture 1 of enclosure 1). The stormboxes were jetted in two different levels (picture 2 of enclosure 1).

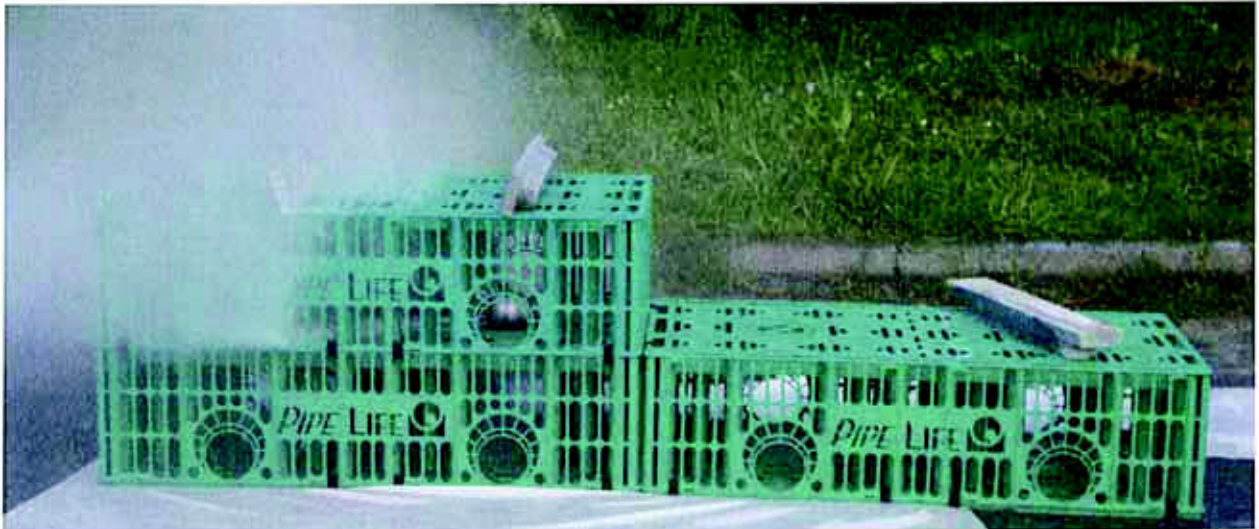
Picture 1: Test assembly

The test was carried out on three "Pipelife Stormboxes" connected to a testing assembly (picture 1 of enclosure 1). The stormboxes were jetted in two different levels (picture 2 of enclosure 1).

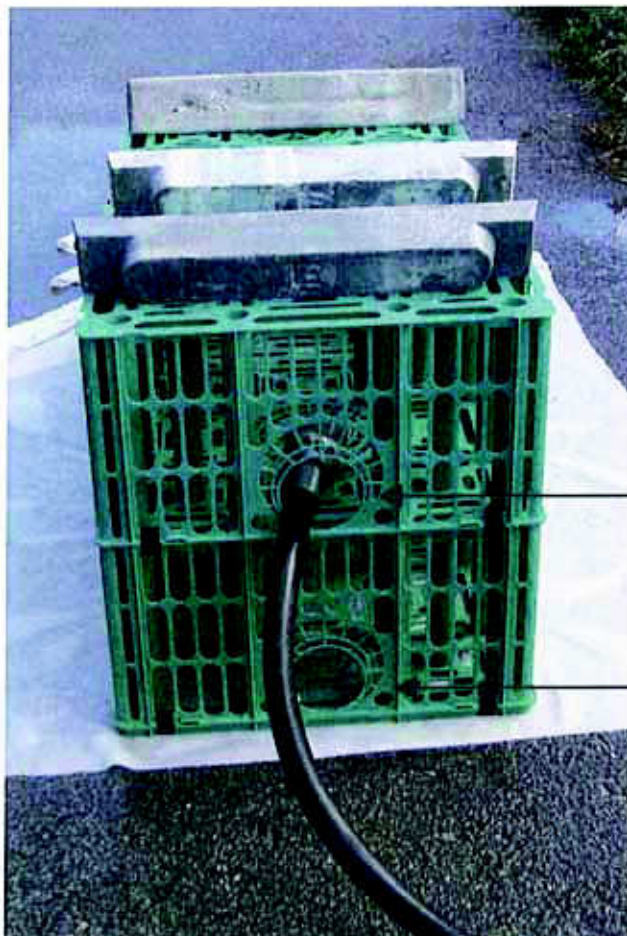
Level 2

Level 1

Picture 2: Different jetting levels
