# Testing of Pipelife oil separator in a manhole, NS6, class 2

**Test report**

**File number:** 362164/2010

**Carried out for:**  
Pipelife Nederland B.V.

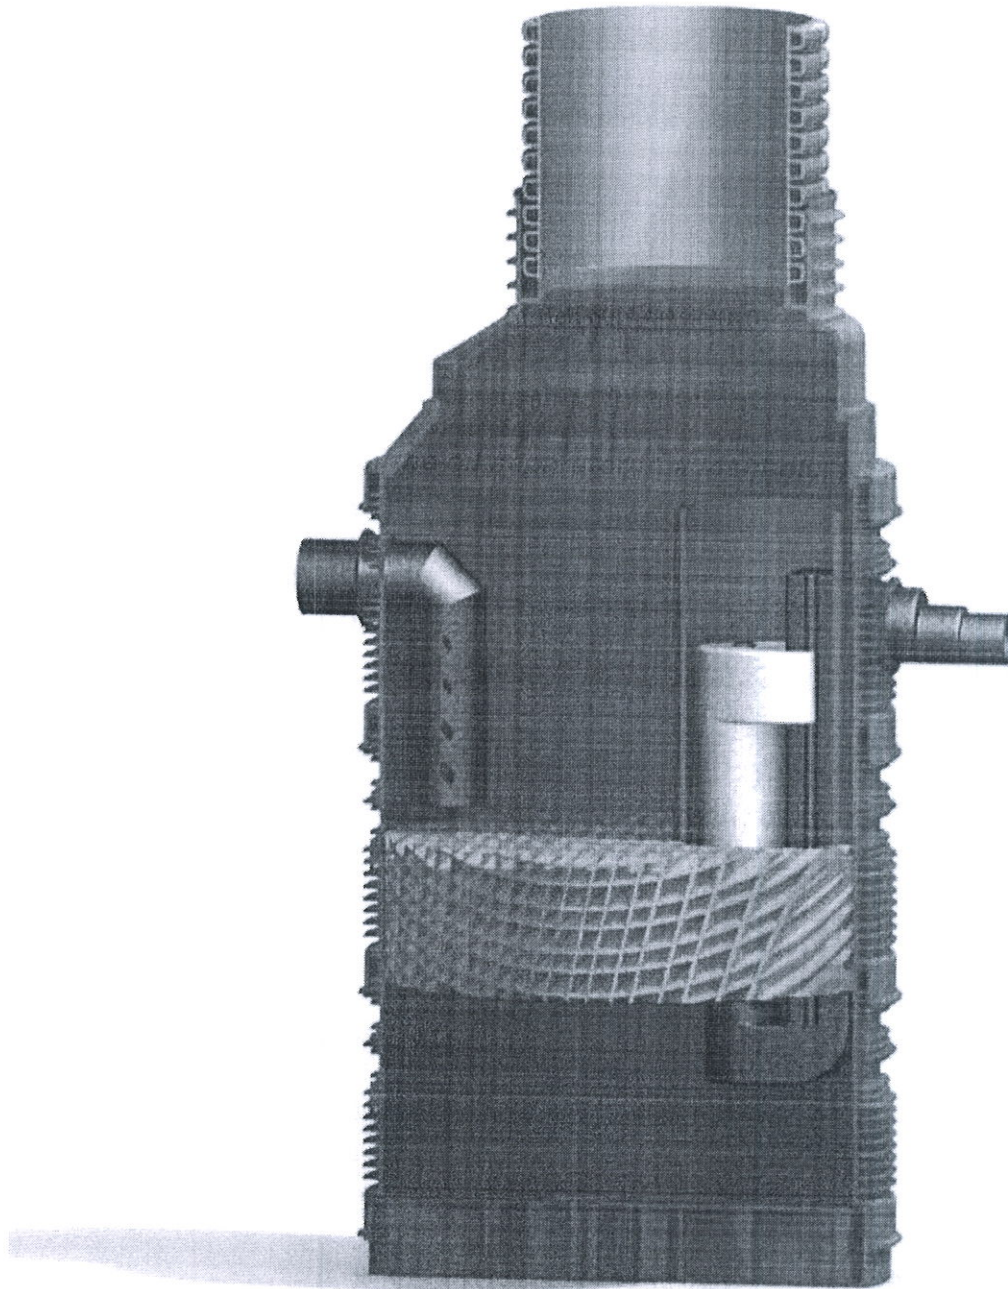
*Supplement 2: Picture of the oil separator in a manhole, NS6, class 2*

The oil separator is build in a manhole, nominal size NS 6, class 2. There was no sludge trap combined to the separator.

All materials are HDPE, except for the filter and the chamber itself, which is PP. All metals part is stainless steel.

Inlet is  $\varnothing 160$  mm and outlet is  $\varnothing 125$  for the 6 l/s separator. A picture of the separator is shown in supplement 2. Testing was carried out on a prototype-separator.

The conformity of the test separator with the manufacturer's construction drawings has been controlled. The main dimensions tally with the manufacturer's drawing.
